# **Shops Enter Repair and Failure Information for Plants**

## **Tango™ Repair Tracker Standardizes Root Cause Analysis and Repair Reporting**

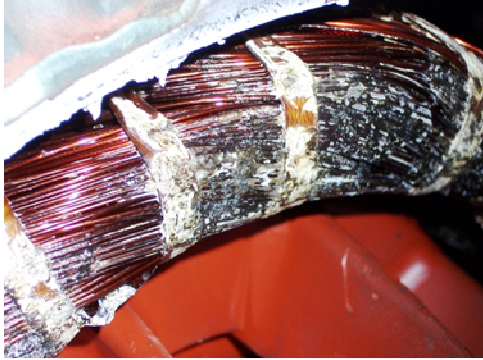
Figure 2: Photograph to support inspection findings

As an example, a motor was removed from service with shortened windings. A costly replacement or rewind will be necessary. At the repair shop the motor is inspected and the inspector finds that the motor windings are full of grease. The root cause of failure is excessive lubrication. The shops' cause of failure analysis including photographs of the failure and inspection summary document provided in Figures 1-3.

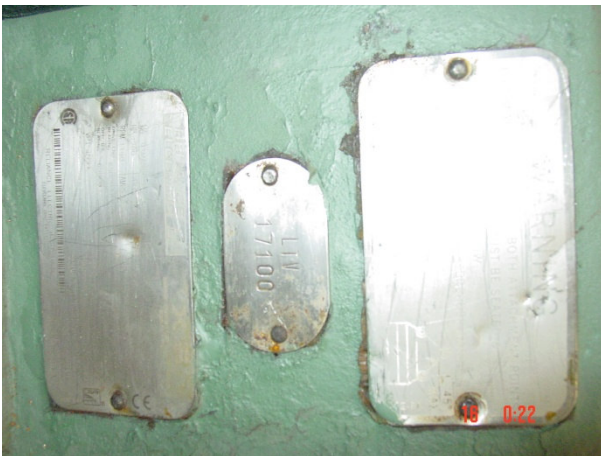
Fig 4 – Plant Equipment Tags

When a piece of equipment is received by a repair facility, They may enter information for that equipment's Plant Tag Number into the Tango Equipment Tango Repair Tracker™ Web Service. A "Plant Tag Number" is used to uniquely identify and track each piece of equipment through its lifecycle, and is usually attached to the equipment as a brass tag (Figure 4). That vendor uses the web browser based Repair Tracker system to enter information as the repair job progresses, without having any special software installed on the shop's computers.
