# Reliability Information Management

# Track BOTH Location & Equipment Reliability

As each unique asset moves through its lifecycle,  
Reliability Information is generated for that Asset Component  
AND for the Functional Service Locations it may occupy.

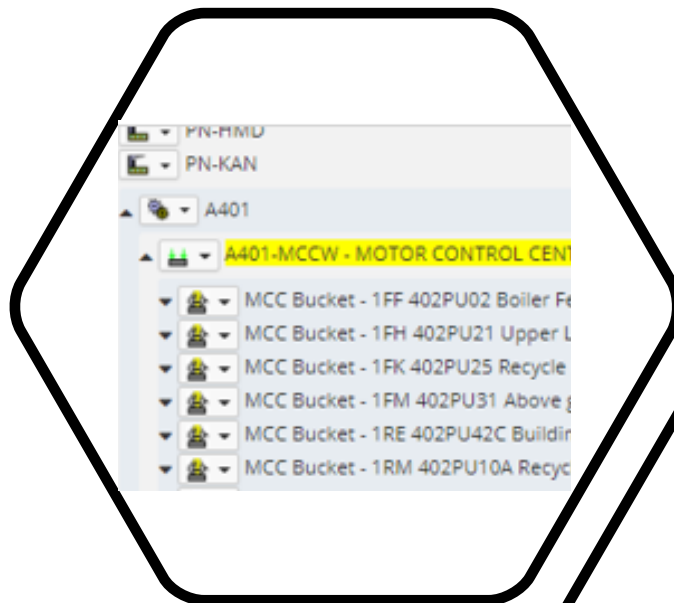
# Functional Location Tree

- Location reliability management starts at the component level
- Practically all condition monitoring technologies can be effective without knowing much detail about the individual asset serving a location

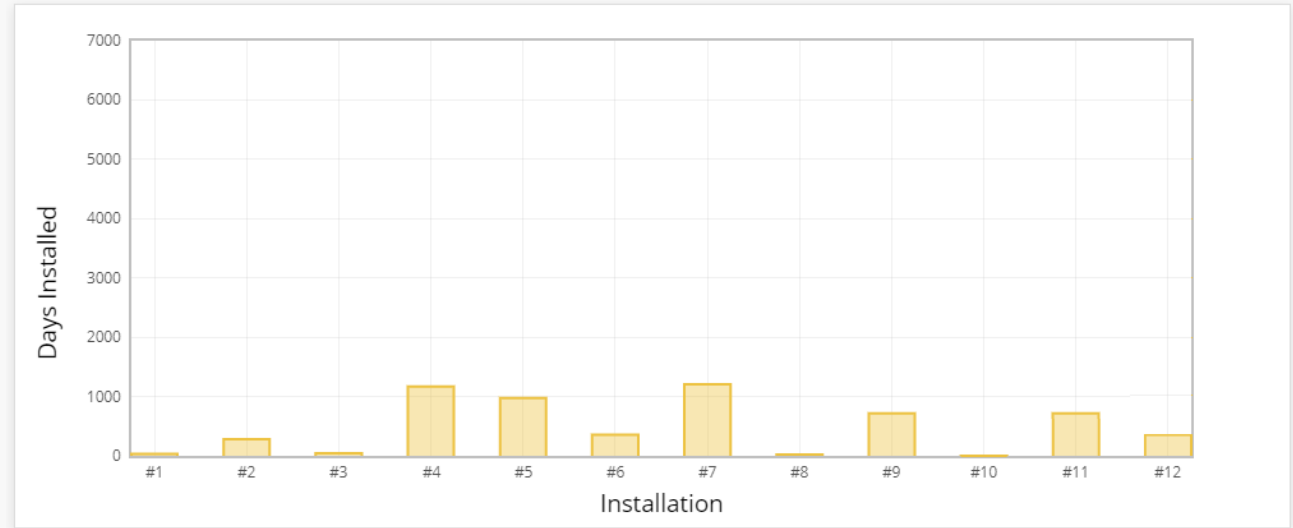
## Location History Report

- The Functional Location history shows short MTBF due to repetitive bearing problems
- Information shows that several different motor ID's served in this location over time, yet suffered bearing problems

101 Cooling Tower » Tower » CLDWELL » MOTOR1

Days Installed

### Installation History

Plant Tag	Start	End	Days	Type	Remarks
▼	1452	Jun 07, 2019	Still Installed	(346)	Install 12	
▼	1450	Jun 01, 2017	Jun 07, 2019	736	Install 11	
▼	55	May 31, 2017	Jun 01, 2017	1	Install 10	ⓘ Removal: WOULD NOT COME UP TO SPEED
▼	1450	Jun 16, 2015	May 31, 2017	715	Install 9	ⓘ Removal: BEARING PROBLEMS
▼	55	May 23, 2015	Jun 16, 2015	24	Install 8	ⓘ Removal: BEARING PROBLEM - 600 AMPS WHEN LOADED
▼	1450	Jan 31, 2012	May 23, 2015	1207	Install 7	ⓘ Removal: BEARINGS
▼	1450	Mar 01, 2011	Jan 31, 2012	336	Install 6	ⓘ Removal: ICE PROBLEMS ON TOWER - WINDING GROUNDED
▼	3004	Jun 16, 2008	Mar 01, 2011	977	Install 5	
▼	1450	Apr 12, 2005	Jun 16, 2008	1168	Install 4	ⓘ Removal: ROUTINE CHANGE
▼	1758	Mar 01, 2005	Apr 12, 2005	42	Install 3	
▼	3591	May 23, 2004	Mar 01, 2005	281	Install 2	
▼	1449	Apr 18, 2004	May 23, 2004	35	Install 1

- Underlying Equipment Lifecycle history reveals water contamination root cause for the bearing failures
- In this example, the location & equipment histories were in separate Excel sources for many years
- Once combined in a single database with combined location/equipment historical tracking the underlying root cause was far more obvious.
